Huddleston Roof Replacement Project  
Bedford County Public Schools  
Addendum 1  
3/22/24

# ASBESTOS ABATEMENT DESIGN

## *Huddleston Elementary School*

**Asbestos Abatement Design**  
**Huddleston Elementary School – Roof Replacement**  
**1027 Huddleston Drive; Huddleston, Virginia 24104**

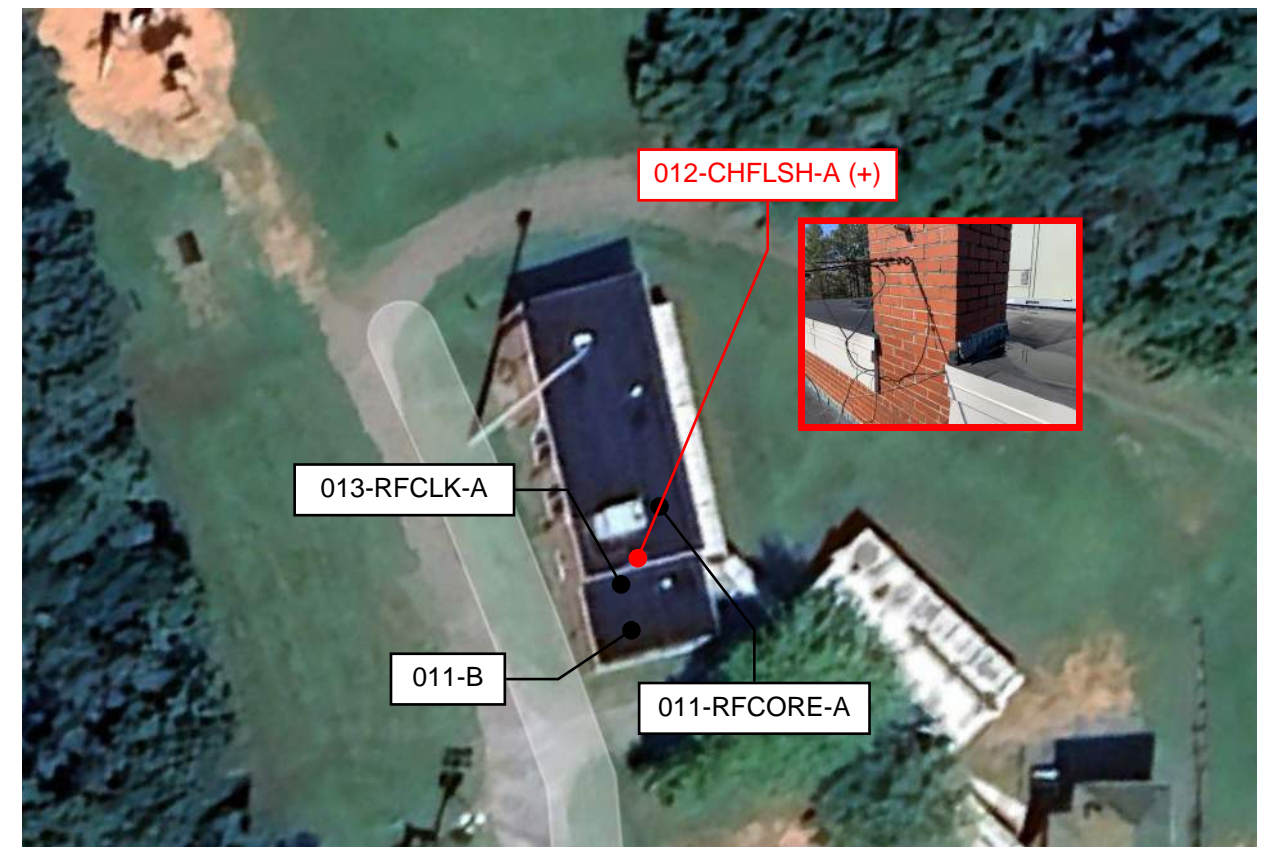
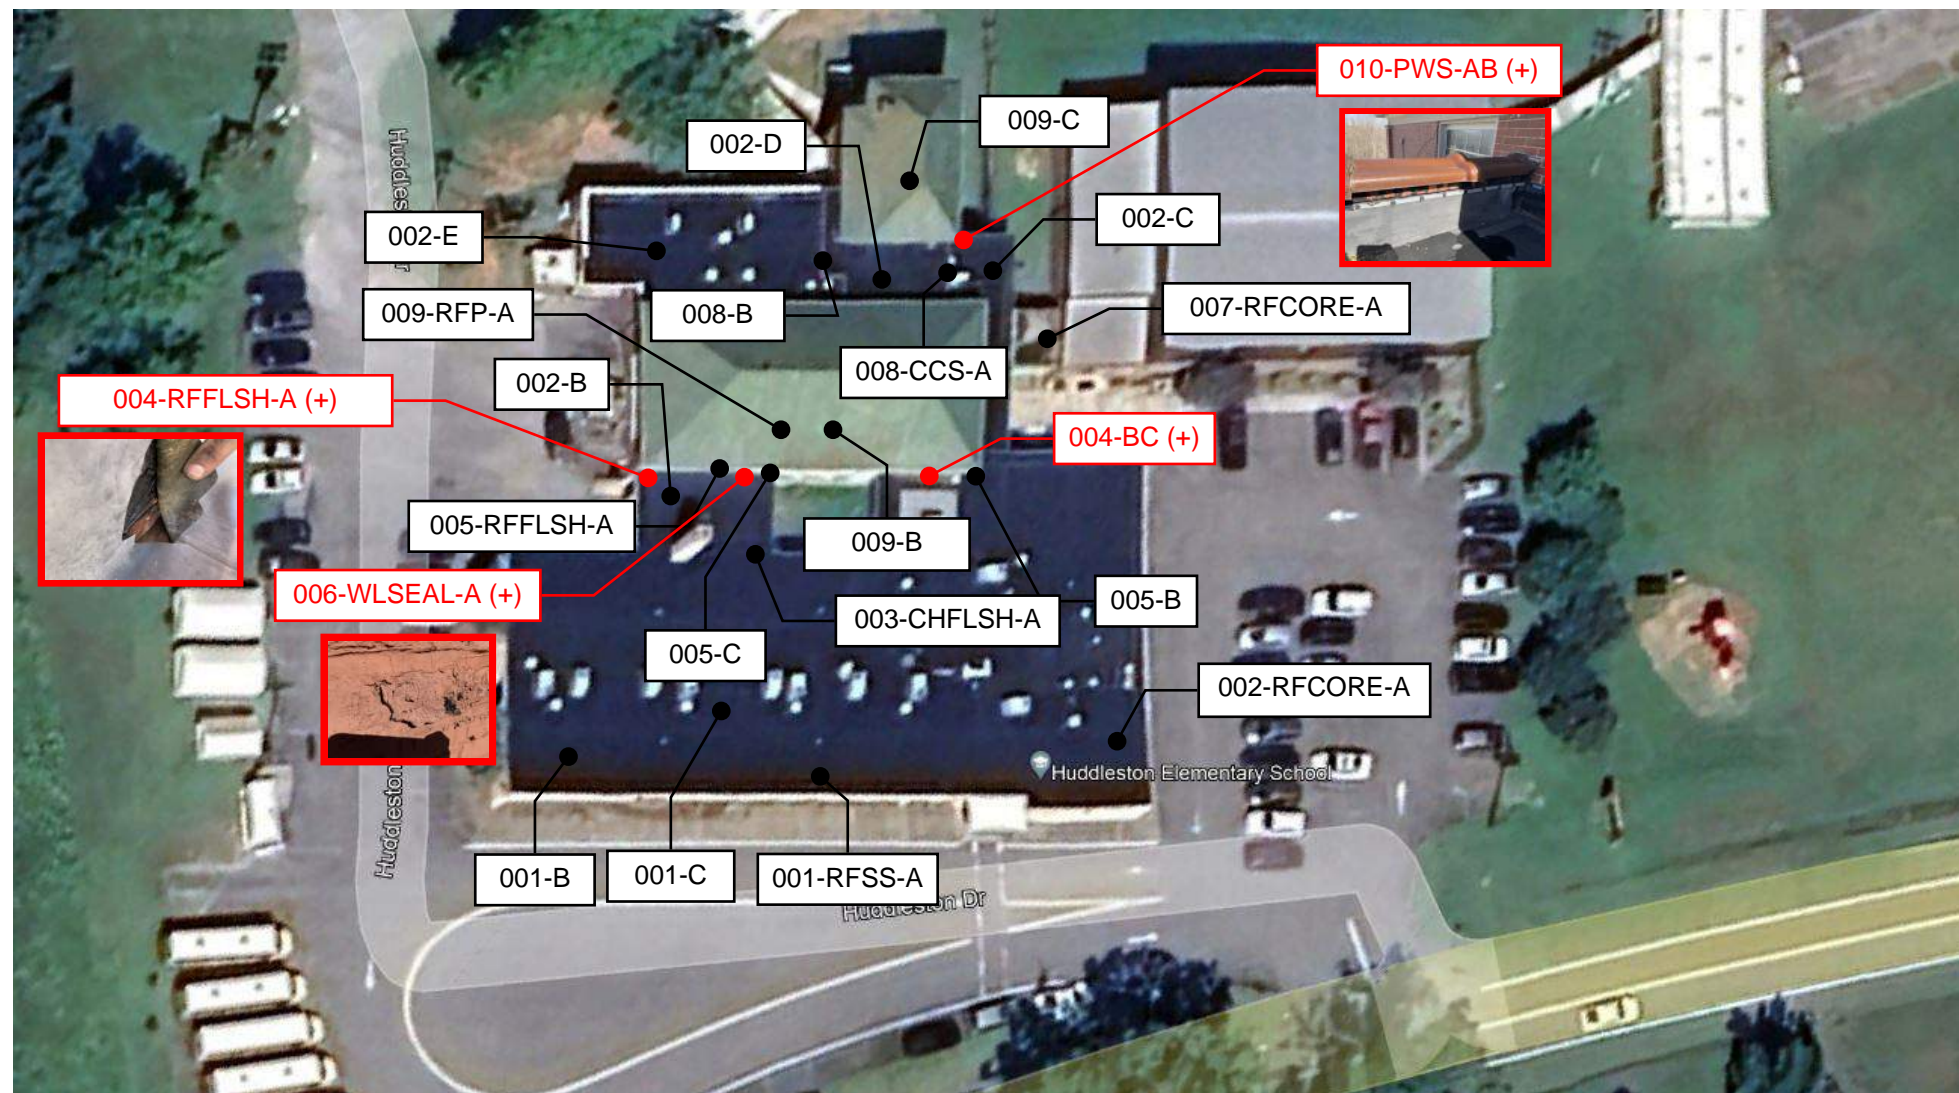
Suspect Asbestos-Containing Material  
Sample Collection Locations

Sample No.	Material Description/	Location	Estimated Quantity	Lab Results (% Asbestos)	Condition/ Friable Y/N
004-RFFLSH-ABC	BLACK ROOF FLASHING MATERIAL	BRICK WALL SYSTEM(S), PARAPET WALL SYSTEM(S)	+/- 450 SF	30% CHRYSOTILE	FAIR / N
006-WLSEAL-A	BLACK WALL SEALANT (ROOFING CEMENT DEBRIS)	BRICK WALL SYSTEM	+/- 60 SF	3% CHRYSOTILE	DAMAGED / N
010-PWS-AB	BLACK PARAPET WALL SEALANT	PARAPET WALL SYSTEM(S)	+/- 70 SF	8% CHRYSOTILE	DAMAGED / N
012-CHFLSH-A	BLACK CHIMNEY FLASHING	CHIMNEY UNIT, ANNEX BUILDING	+/- 7 SF	8% CHRYSOTILE	FAIR / N
<b>INTENTIONALLY LEFT BLANK</b>					
001-RFSS-ABC	BLACK EPDM ROOFING SYSTEM SEAM SEALANT	ROOFING SYSTEM, MAIN FIELD	N/A	NONE DETECTED	N/A
002-RFCORE-ABCDE	EPDM ROOFING SYSTEM CORE (LAYERED)	ROOFING SYSTEM, MAIN FIELD	N/A	NONE DETECTED	N/A
003-CHFLSH-AB	TAN CHIMNEY FLASHING	CHIMNEY UNIT	N/A	NONE DETECTED	N/A
005-RFFLSH-ABC	BLACK AND RED ROOF FLASHING CAULK (METAL STRIP SEALANT)	ROOFING SYSTEM, ROOF FLASHING(S)	N/A	NONE DETECTED	N/A

**Hurt & Proffitt recommends the following asbestos-containing materials be removed prior to proposed roofing system replacement activities that may damage the materials and subsequently cause fiber release:**
